TECHNICAL REPORT NO. 3-744

TRAFFICABILITY TESTS ON UNCONFINED ORGANIC TERRAIN (MUSKEG)

Report 1

SUMMER 1963 TESTS

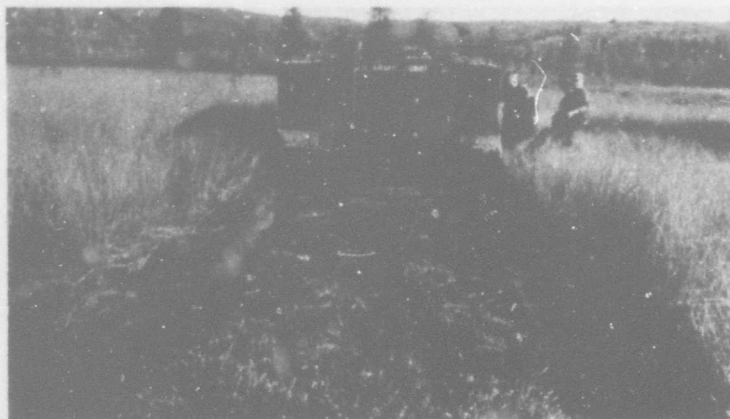
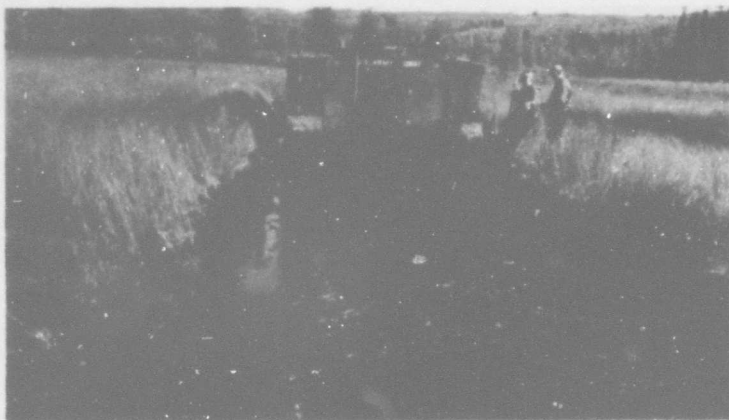
Fig. 15. M59 armored personnel carrier, test 21

31. M59 armored personnel carrier. Data plots of the M59 tests are shown in fig. b of plate 1. Thirteen tests were run; three tests (20, 21, and 25) resulted in immobilizations on the 17th, 39th, and 11th passes, respectively, and one test (5A) resulted in the vehicle experiencing difficulty (high track slip) on the 8th through 10th passes until it moved enough muskeg out of the ruts for the tracks to reach permafrost. Fig. 15 shows the M59 at various intervals during test 21.

a. After 10 passes

b. After 20 passes

c. Immobilized on 39th
pass

pass, the ruts were already 23 in. deep, and the vehicle was traveling within 13 in. of the permafrost, apparently close enough to benefit therefrom.

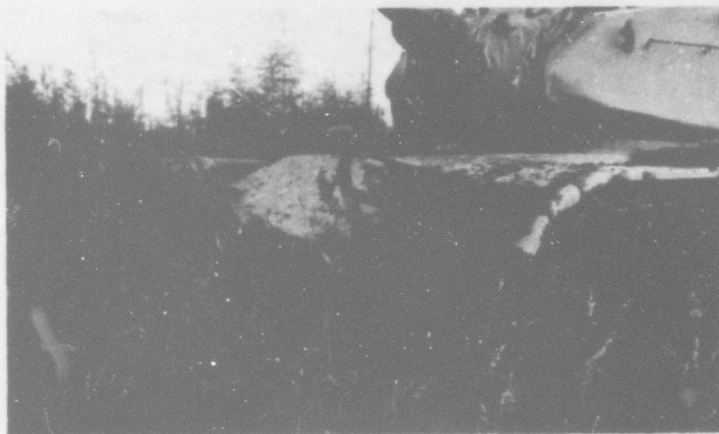
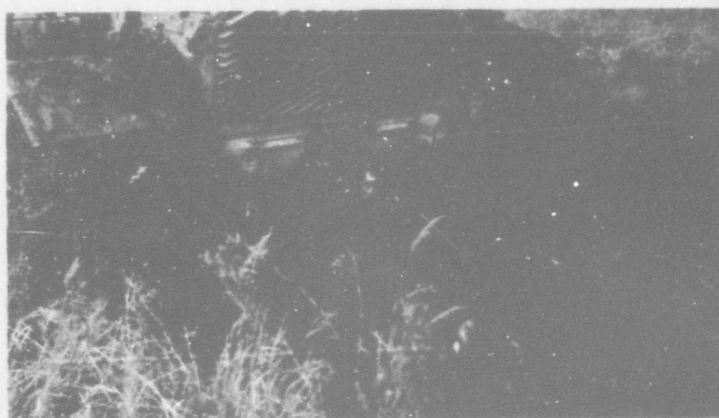
Fig. 17. M60A1 immobilized on first pass by buildup of vegetation in front of vehicle, test 9

39. Scenes illustrating the effect of rutting on two M60A1 tests are shown in figs. 17 and 18. In fig. 17 front and rear views of the M60A1 immobilized on the first pass in test 9 show the effects of deep rutting on early passes. Vegetation is sheared by the underbelly of the vehicle and piled up in front,

a. Front view showing buildup of vegetation

b. Rear view showing sheared area between tracks

thereby causing a halt in forward progress. In this test the vehicle was able to back up and continue traffic in the initial part of the test lane while riding on permafrost. In a similar test (test 8), the vehicle was unable to back over the pile of muskeg accumulated at the end of the test lane (fig. 18a) but was able to go forward and, with a series of back-and-forth movements, turn completely around (fig. 18b) and then go out of the test lane at a slight angle (fig. 18c). The vehicle was riding on permafrost for most of this operation.

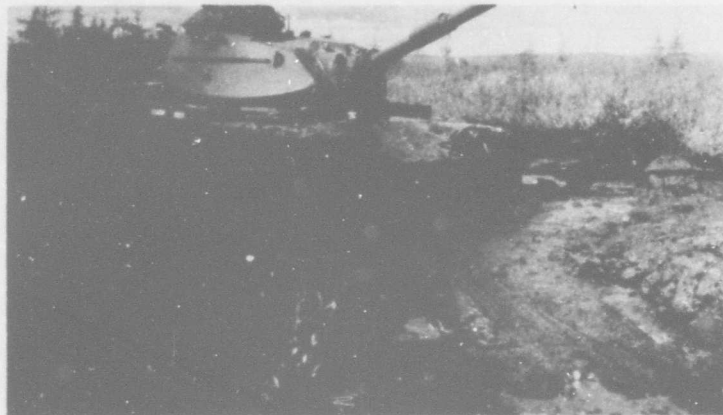
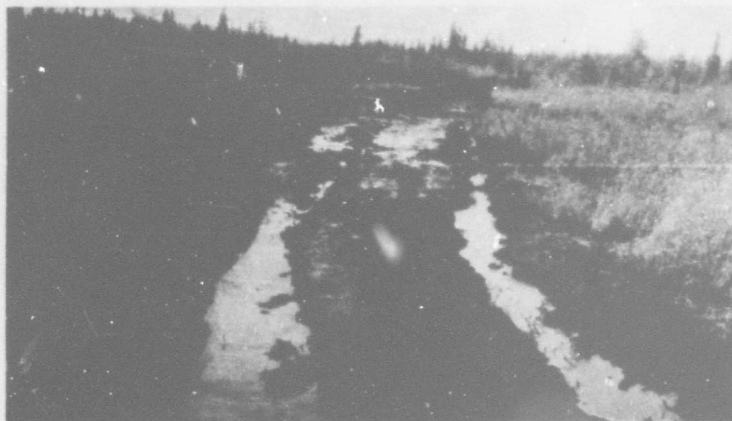
Fig. 18. M60A1, test 8

a. Immobilization in reverse, on pile of muskeg

b. Turning around by series of back-and-forth movements

c. Test lane after M60A1 departed at a slight angle to original lane
